WADC TECHNICAL REPORT 53-192

MECHANISM OF RAIN EROSION

Part XI. Effect of Residual Stresses and of Molding
Variables on the Erosion Resistance of Nylon

NATIONAL BUREAU OF STANDARDS

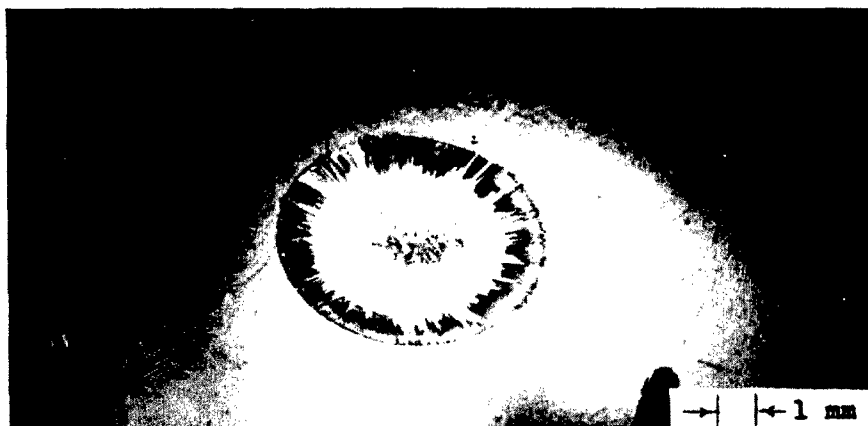
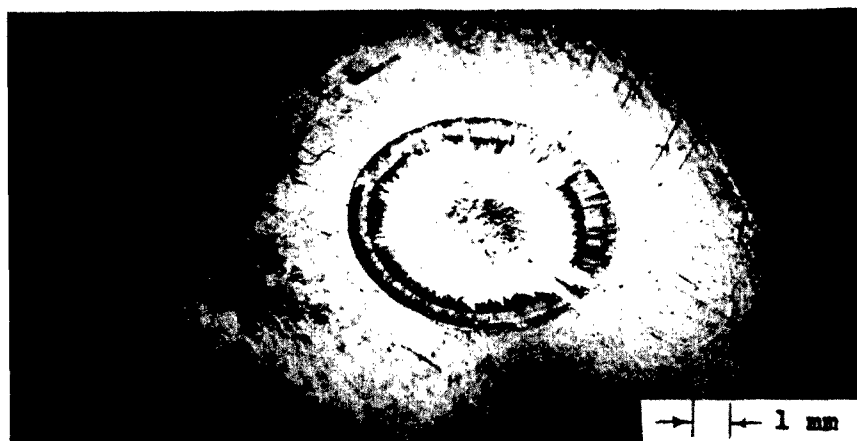
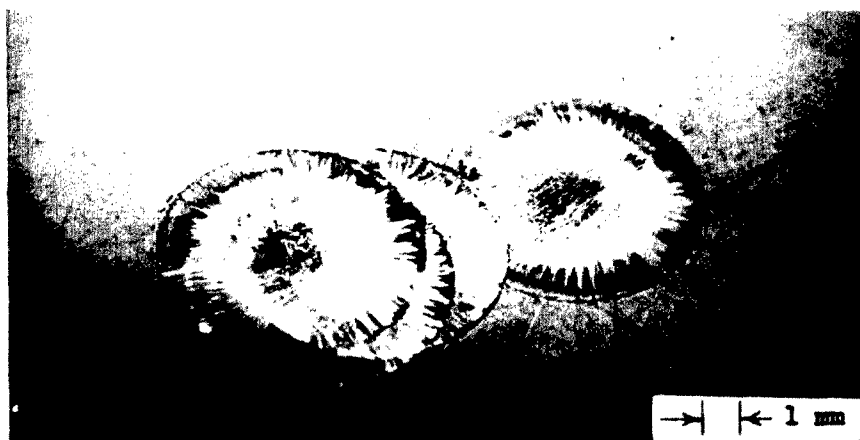
(a) VELOCITY 530 ft/sec

(b) VELOCITY 640 ft/sec

(c) VELOCITY 490 ft/sec

FIGURE 1. SINGLE AND MULTIPLE SHOTS ON NYLON FM-10001 WITH DEFORMING
LEAD PELLETS

A test of the nylon sheet was also made using deforming lead pellets that were fired from the Benjamin air rifle. Deforming lead pellets that were fired against it at velocities of 490 ft/sec, 530 ft/sec, and 640 ft/sec left small circles of abrasion but produced no cracks. See Figure 1. No cracks were produced even on multiple impingement with lead pellets at a velocity of 490 ft/sec. See Figure 1(c). Inspection at X62.5 magnification of the structure of the dim circle made at the impingement velocity of 530 ft/sec showed that it consisted of very fine lines in the radial direction. See Figure 1(a). These lines may have been caused by the drag of the deforming lead over the surface of the nylon as the lead pellet flowed radially during the collision. The damage mark made in the nylon by a deforming lead pellet at an impingement velocity of 640 ft/sec consisted of a very shallow depression and a circle of abrasion. See Figure 1(b). In the case of neoprene coatings, the damage produced by the impingement of deforming lead pellets often consists of a circular cut surrounded by a coating-bubble.

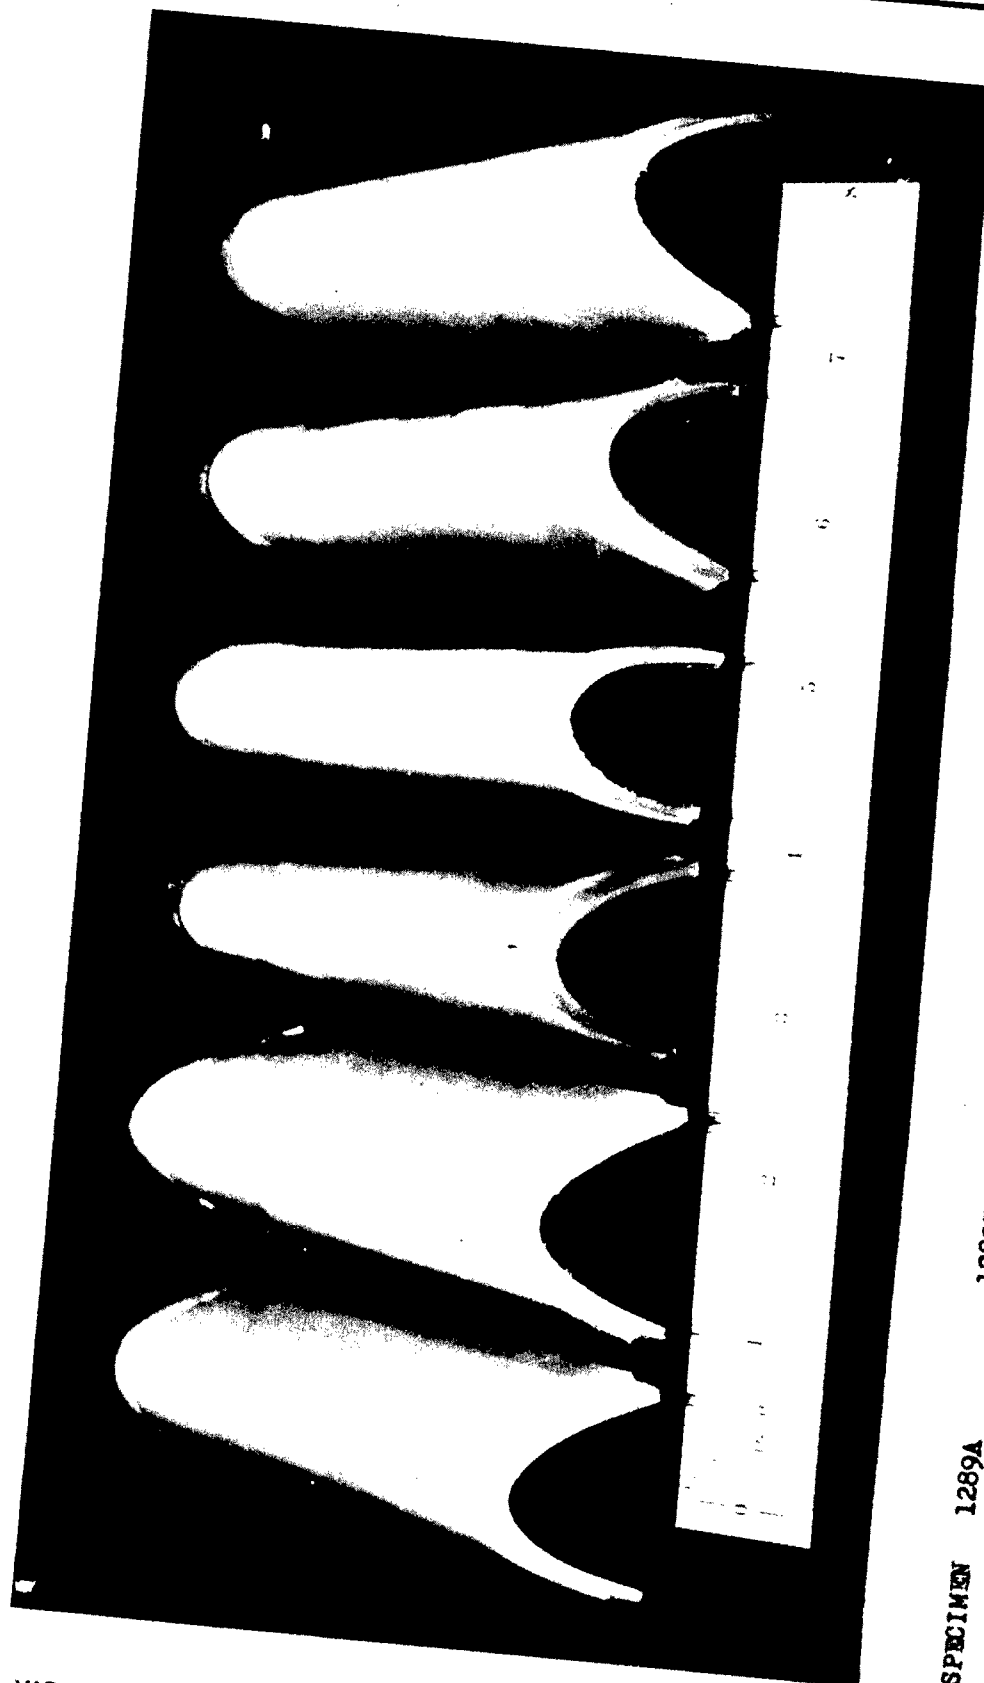
SPECIMEN	1289A	1289B	1345A	1345B	1346A	1346B
TEST TIME	25 sec	1 min	5 min	15 min	20 min	30 min

FIGURE 2. SPECIMENS OF NYLON PA-10001 AFTER VARIOUS TEST INTERVALS. STUDY II.

In addition, three of the specimens had changed contour due to creep since the time that they were formed. Only specimen 1345B retained the 1-in. chord dimension of a Cornell Aeronautical Laboratory rain erosion specimen. See Figure 2.

Specimen 1345B was tested for 15 min. It was the only nylon specimen that did not change shape due to creep. See Figure 2. The surface layers of this specimen along the leading edge and to a distance about half-way down the sides of the specimen had been discolored to a light tan by superheating during molding. However, a large part of the embrittled tan layer had been removed by the waterdrop impingement of the rain erosion test, and only the fringes of it remained about half-way down each side. The large areas

Specimen 1346A was tested for 20 min. It had changed shape due to creep since it was formed so that the 1-in. distance from side to side of the specimen had increased to 1-1/4 in. See Figure 2. The entire surface of the specimen was a strong tan or light brown color. It was, however, not quite as dark as specimen 1345A. The glossy tan surface layer was removed by waterdrop impingement during the rain erosion test from an approximately 3/4-in. swath down the length of the specimen on the leading edge. Severe erosion, which had progressed further than on specimen 1345B, was restricted to the center of this swath. The light-colored plastics along the boundaries of the swath from which the embrittled tan layer had been removed had a dull but relatively smooth surface as on specimens 1345A and 1345B. The outline that remained of the originally raised disk of plastics, which marked the location of the orifice through which the original plastics sheet had been injection molded, could be seen on the inner surface at the edge of one side. The same type of stress-crack formation could be seen as that observed on specimens 1289A, 1345A, and 1345B. At one end of this specimen stress-cracks could be seen in a narrow band which had been protected from the rain impacts. This band extended across the leading edge. This observation indicates that the stress-cracks were present before the specimens were tested.
